# Testing of New Bridge Rail and Transition Designs

Volume XIII: Appendix L

32-in (813-mm) Thrie-Beam Transition

PUBLICATION NO. FHWA-RD-93-156

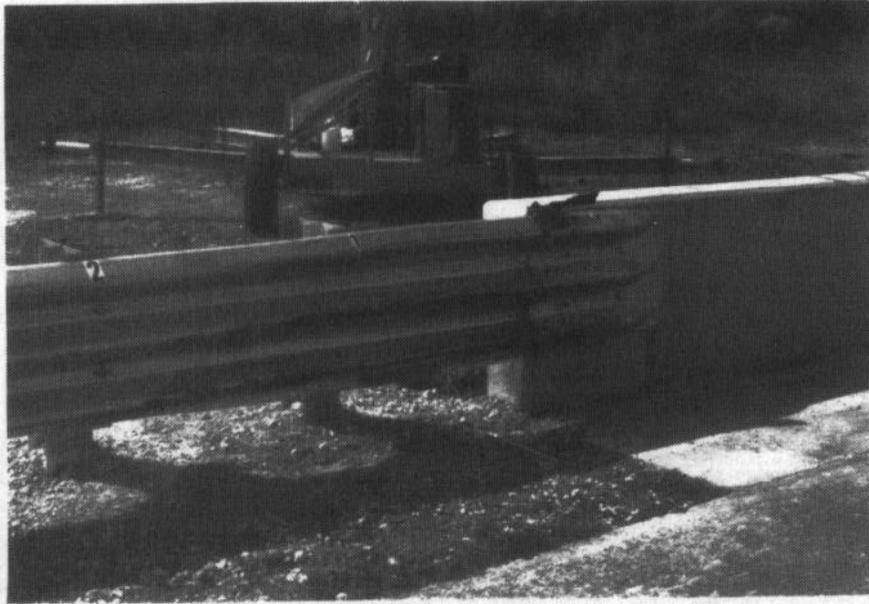
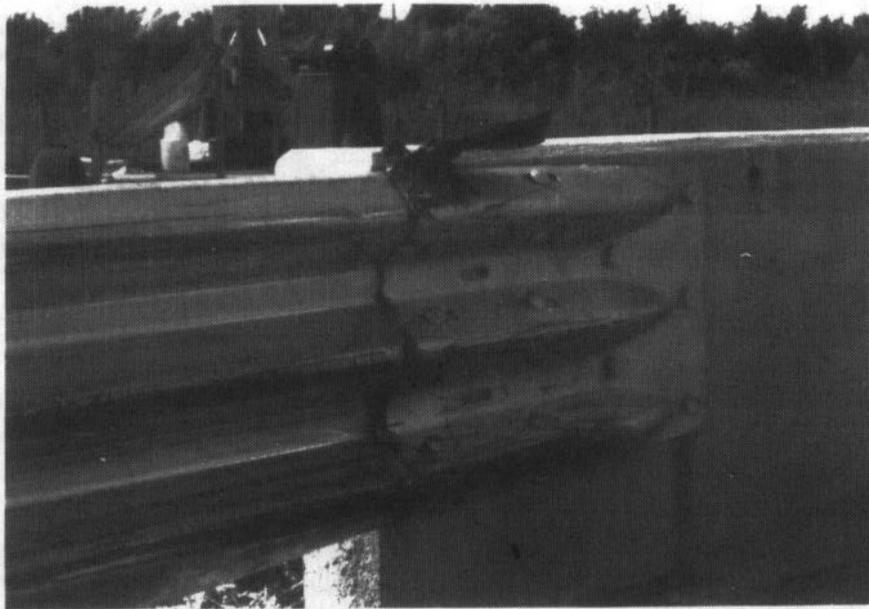
Figure 7. Thrie-beam transition after test 7069-19.

As can be seen in figure 7, the transition received minor damage, most of which was cosmetic in nature. Maximum lateral deformation was 0.5 in (13 mm) at the post 2. The vehicle was in contact with the transition for 8.5 ft (2.6 m).

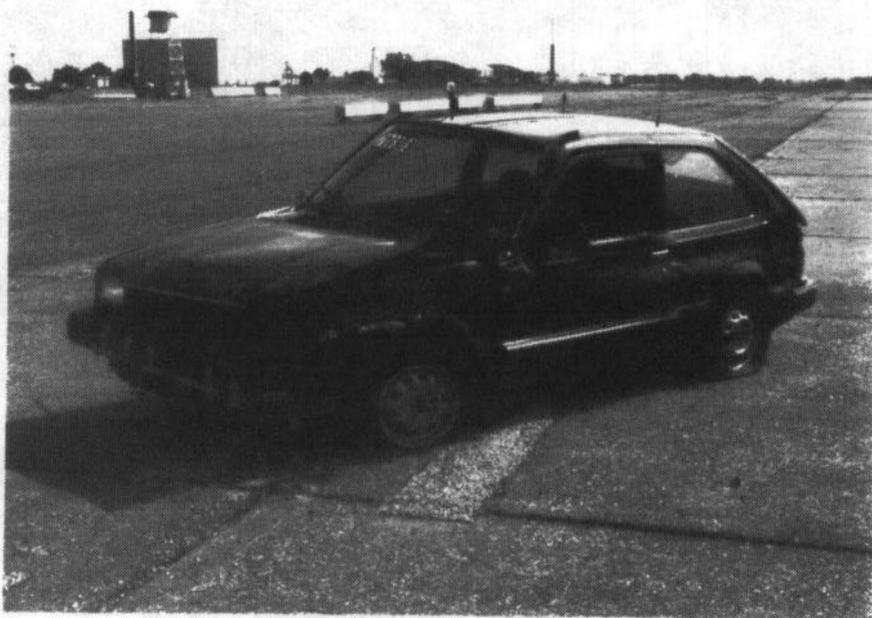
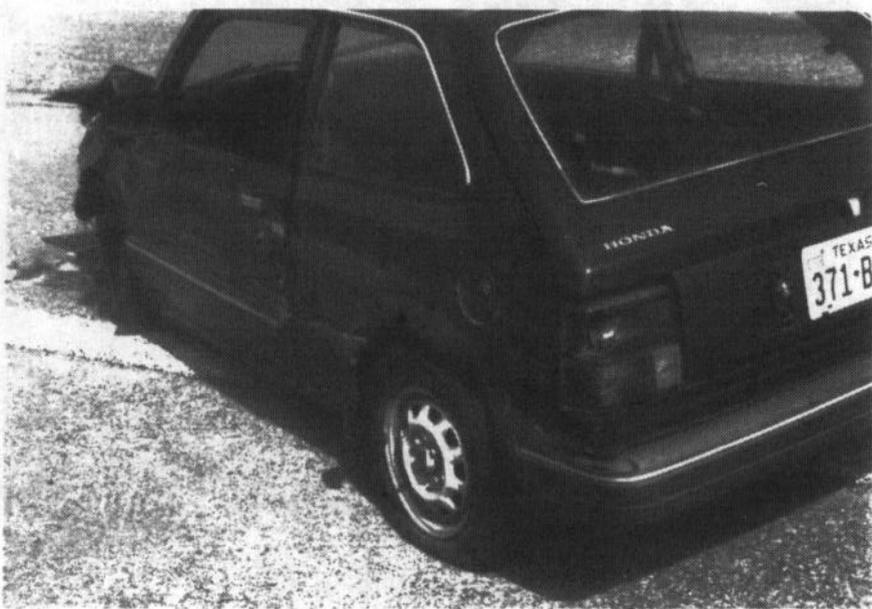
Figure 8. Vehicle after test 7069-19.

The vehicle sustained damage to the left side as shown in figure 8. Maximum crush at the left front corner at bumper height was 11.0 in (279 mm). The strut and c.v. joint on the left side were damaged and the roof was bent. The left front wheel was canted inward at the bottom and pushed back into the fender well. The left side window was broken out by the head of the dummy. Also, damage was done to the front bumper, hood, grill, radiator and fan, the left front quarter panel, the left door, left rear quarter panel, and left rear tire and rim.

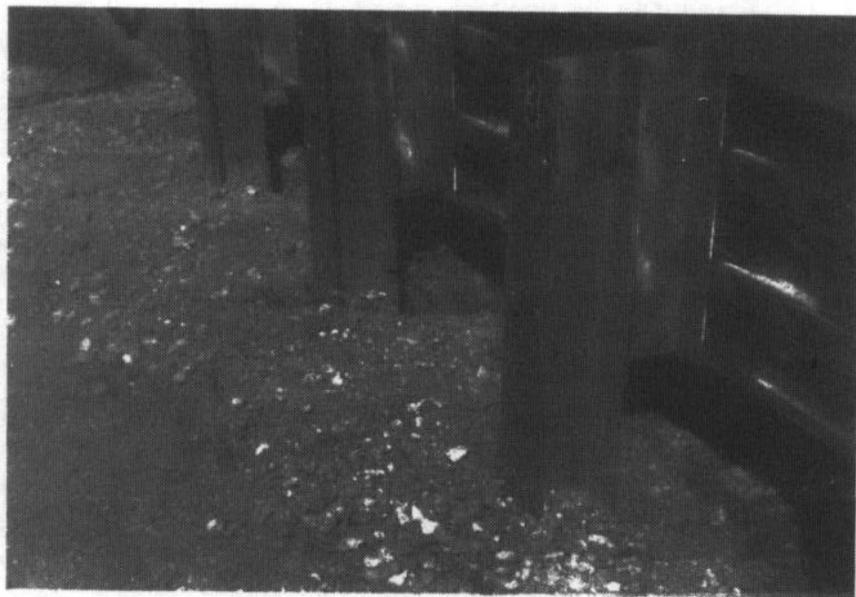
Figure 20. Thrie-beam transition after test 7069-20.

As can be seen in figure 20, the transition received moderate damage. Maximum lateral deformation was 6.5 in (165 mm). The vehicle was in contact with the transition for 8.5 ft (2.6 m).

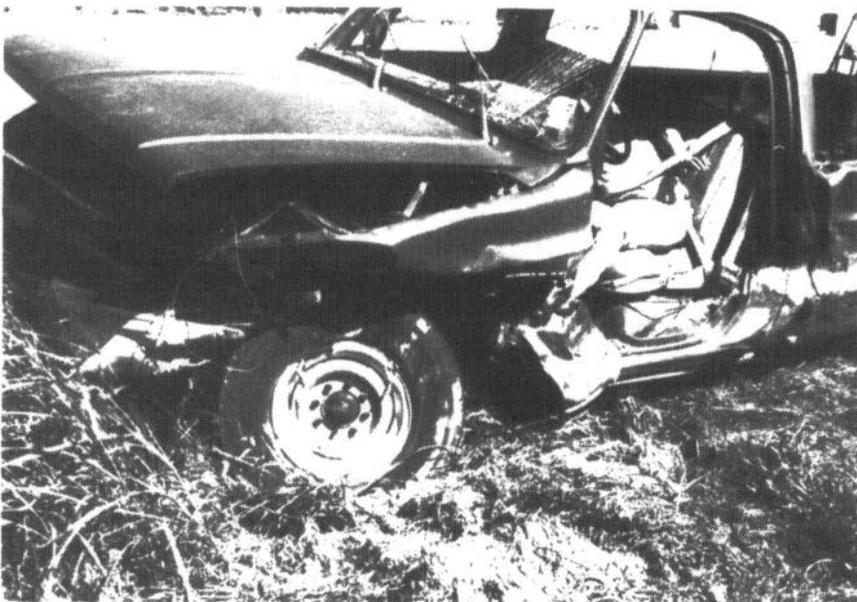
Figure 21. Vehicle after test 7069-20.

The vehicle sustained damage to the left side as shown in figures 21 and 22. Maximum crush at the left front corner at bumper height was 22.0 in (559 mm). The sway bar and upper and lower control arm, the left side were damaged and the roof was bent. The left front wheel was canted inward at the bottom and pushed back into the fender well. The left side window was broken out and the door was off. Also, damage was done to the front bumper, hood, grill, radiator and fan, left front quarter panel, left rear quarter panel, and left rear tire and rim.

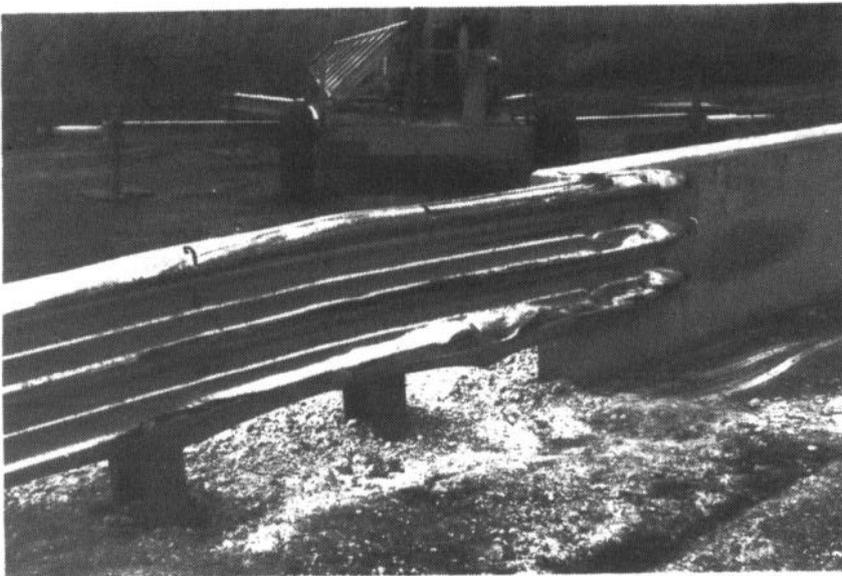
Figure 40. 32-in (813-mm) thrie-beam transition after test 7069-21.

As can be seen in figure 40, the transition received moderate damage. Maximum lateral permanent deformation was 5.0 in (127 mm). The vehicle was in contact with the transition for 14.0 ft (4.2 m).

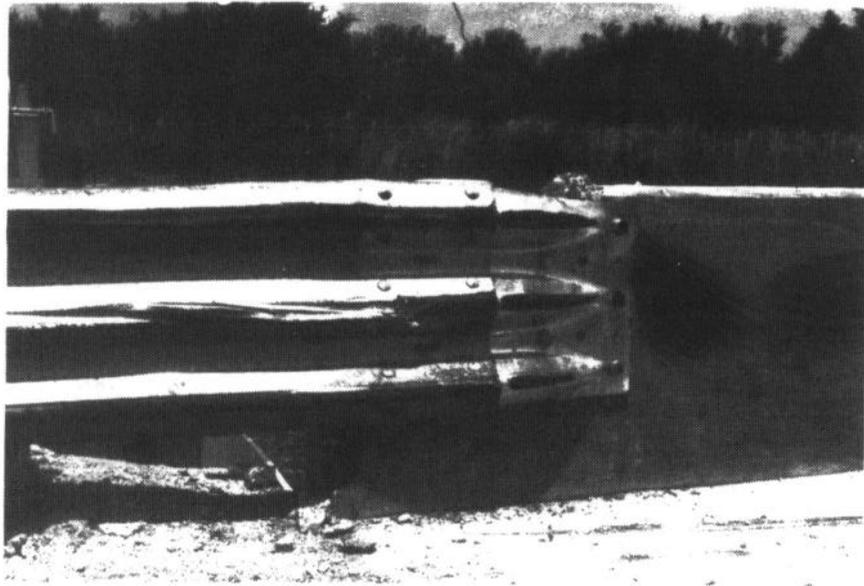
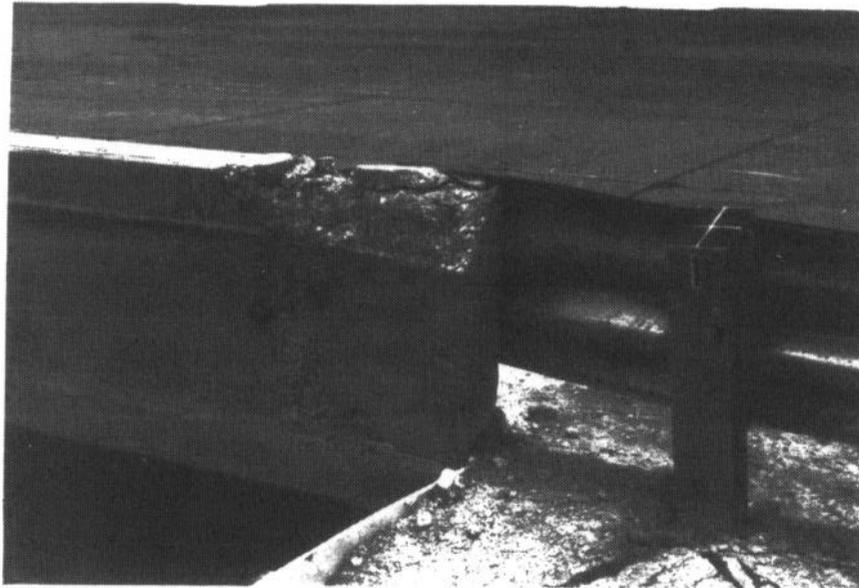
Figure 58. Damage at terminal connection to concrete parapet after test 7069-29.

As can be seen in figure 57, the transition received moderate damage. Maximum lateral permanent deformation to the transition was 10.0 in (254 mm). The end of the concrete parapet where the terminal connector attached was cracked as shown in figure 58. Damage to the terminal connector is shown in figure 59. The vehicle was in contact with the transition installation for 18.5 ft (5.6 m).

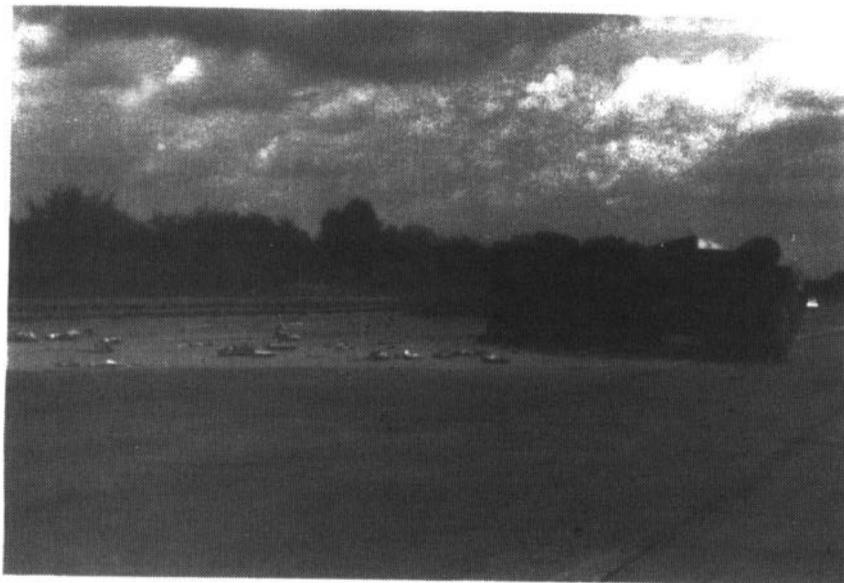
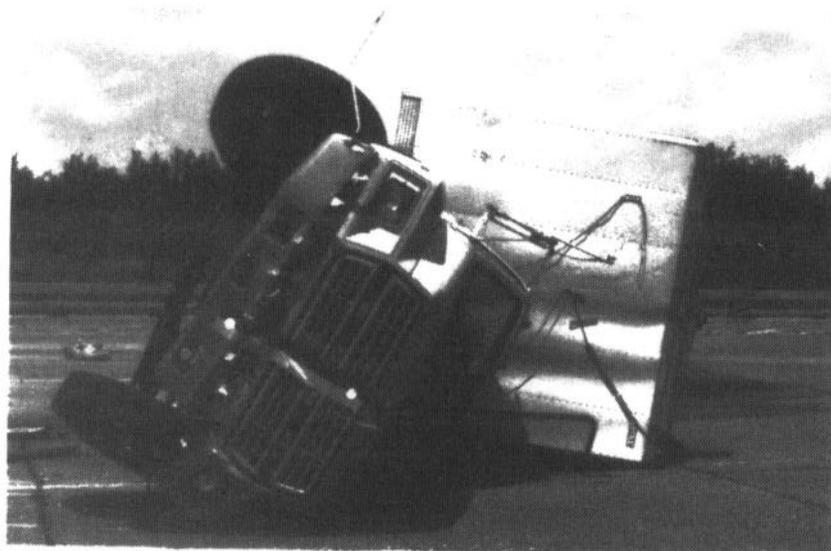
Figure 60. Vehicle after test 7069-29.

The vehicle sustained damage to the left side as shown in figure 60. Maximum crush at the left front corner at bumper height was 13.0 in (330 mm). The floorpan was pushed inward and the cab was bent and twisted. The windshield and rear glass were broken. The frame at the rear axle was bent and the van-box was twisted and torn. The driver side window was broken out and the door was jammed. Also, damage was done to the front bumper, hood, left front quarter panel, and outer left rear tire and rim. The right door was also jammed.
